## Field operation of NICO nitrate measurements in surface waters

Use of the TriOS NICO sensor for Nitrate monitoring in two different flowing waters: James River near Cartersville (Virginia) and Mill Creek at Johnson Drive in Shawnee (Kansas).

### Field operation of NICO nitrate measurement in surface waters

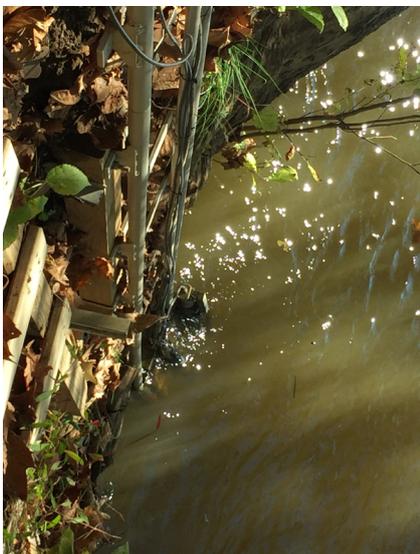
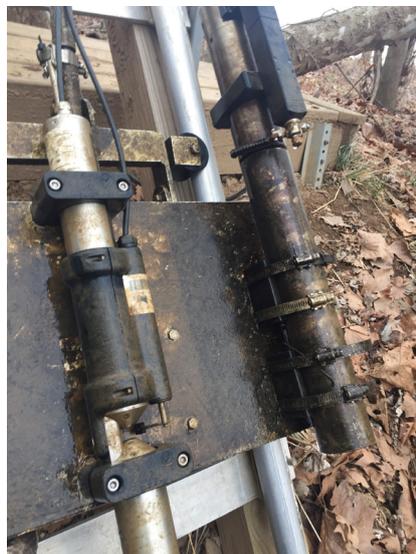
The installation at James River was done using a movable slide on a rail system, which was attached to a bank of the river. The TriOS NICO including the wiper

cleaning system was installed next to a SUNA probe by Seabird, which featured a brush cleaning system.

*Installation NICO (left) and SUNA (right) on rail system at James River.*

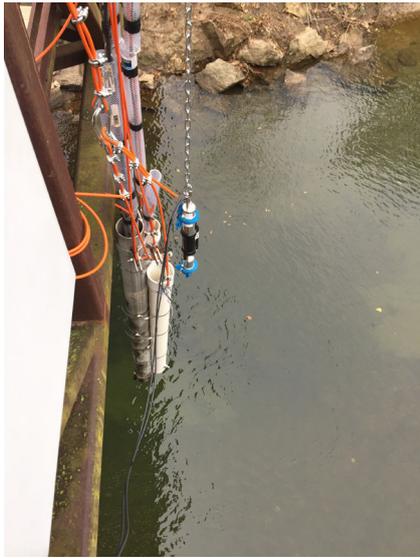
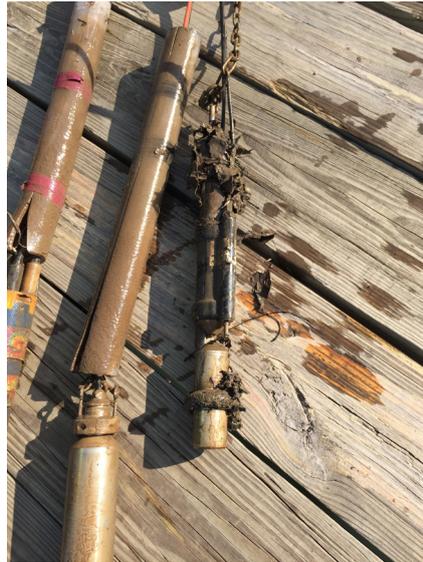
At Mill Creek the NICO probe was installed suspended from a bridge and guided through a PVC pipe into

the water, next to a NITRATAX plus sc by HACH. Both sensors featured a wiper cleaning system.

*Hanging installation of NICO (right) and Nitratax plus sc (middle) at Mill Creek.*

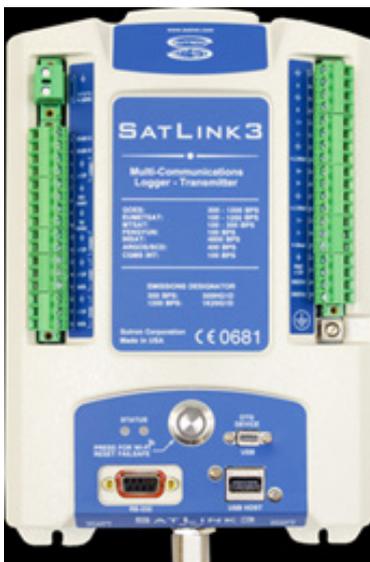
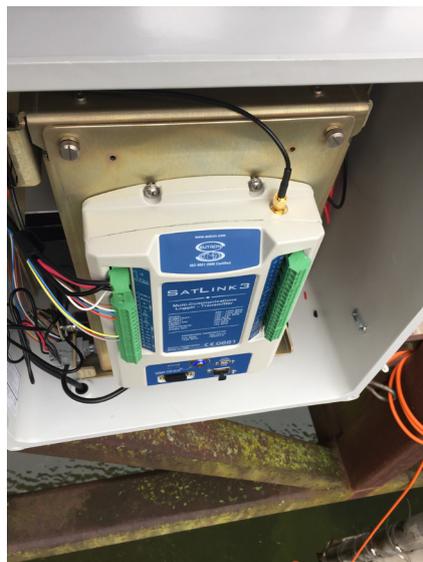
At both sides, the sensors were connected to a SatLink3 data logger by Sutron. The NICO communication was performed directly through the RJ485 interface via

MODBUS RTU. The following measurement cycle was programmed on the SatLink3 data logger:

- The power supply for the NICO probe and wiper is turned on 90 s before measurement and a wiping process is triggered.
- 15 s after turning the power on, the wiper power supply is turned off again.
- After 75 s a nitrate measurement is triggered, nitrate and the quality index is read.
- In case a measurement delivers no result, an error code is put out.
- After 90 s the NICO power supply is turned off.

*SatLink3 Data logger*

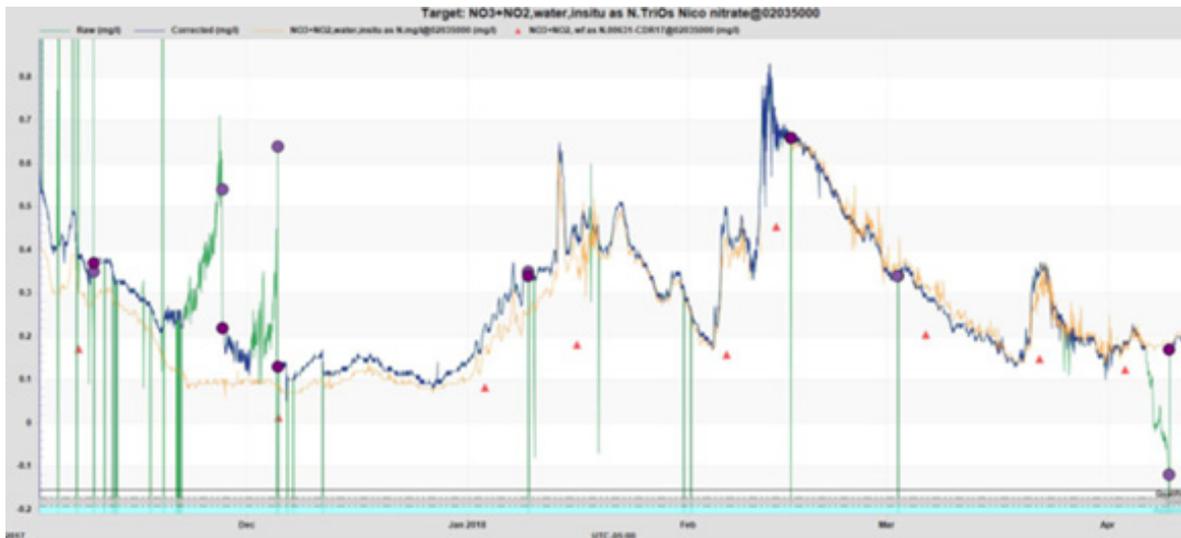
The trial installation at James River started out challenging. Debris such as leaf residue in the measuring gap blocking the wiper, distorted the results and let them drift upwards (as seen in graph). After a manual cleaning and repair of the wiper, the results reverted to accurate levels. By turning the probe into the opposite direction of the water flow this problem could be resolved. Another initial issue was frequent measurement value loss in the first phase of the trial. An

analysis of the software version of the NICO prototype revealed that single measurements were distorted due to solid matter caught in the measurement gap, which caused fault signals. Subsequently, the software was modified and the output value is now calculated as an average from multiple single measurements with an elimination of outliers.

Nitrate data of the NICO sensor over time with raw data (green) and processed data (blue) in comparison with the SUNA sensor (yellow) and lab values (red triangle). Violet dots show the read values of NICO before and after a manual cleaning.

After the elimination of both error sources the NICO sensor produced stable signals in a range between 0.05 and 0.80 mg/l NO<sub>3</sub>-N. The comparison to the Seabird SUNA showed a minor deviation in the first half of the trial period, but was not registered after the wiper repair and thorough manual cleaning of the measurement windows in January anymore. From that date, both probes continuously delivered almost identical results until the end of the trial period. Particular attention should be given to the storm incident with flooding, which occurred February 9-14 and caused

turbidity values of 500 FNU. Despite these challenging conditions (strong currents and turbidity) the NICO sensor was able to deliver reliable data whereas the wiper of the SUNA probe was blocked, which led to a loss of data for the rest of the trial period.

Comparative lab measurements of single samples showed slightly lower results. This small systematic difference however was evaluated as typical due to the measured value subordination to the cross profile of this water.

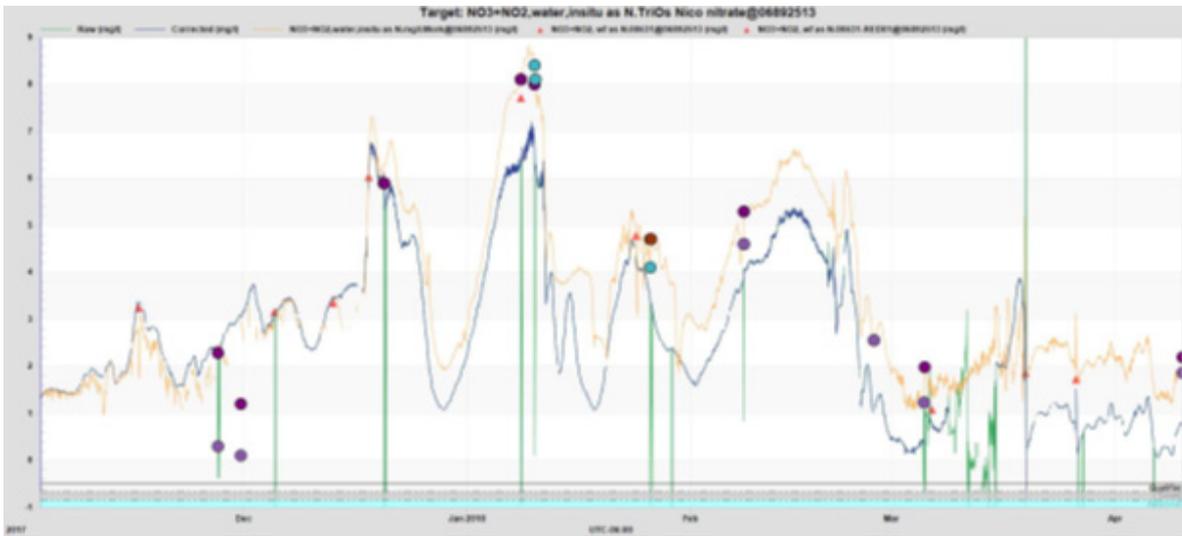
The trial installation of a NICO sensor at Mill Creek proceeded reliably without any special events over the entire trial period from November 2017 until April 2018. The nitrate concentrations ranged between 0.2 and 9.0 mg/l NO<sub>3</sub>-N.

One exception occurred at 5 March when a loose wiper blade was partially blocking the measurement gap. All other short-time surges were caused by maintenance works.

Nitrate hydrographs of the NICO sensor raw data (green) and processed data (blue) in comparison to the NITR-ATAX sensor (yellow) and lab values (red triangle).

A comparison between the NICO probe and the NITRATA plus sc shows good data agreement at the beginning of the trial period. However, the NITRATA

probe broke down in November and had to be replaced by a rental device. From this point onwards the measurement values of the NITRATA were generally higher than the NICO values.

The comparative lab measurements from discrete samples largely validated the NICO data. The somewhat larger deviation on 8 January could be explained by an exceedance of the measurement range. With 10 mm the sensor's path length was too big for this application and for a permanent installation at this site a 5mm path-length would be recommended.
